## Property Visit Report

11 The Groves, STOCKTON-ON-TEES, Durham TS18 3PU

**Report date:** 21st November 2022

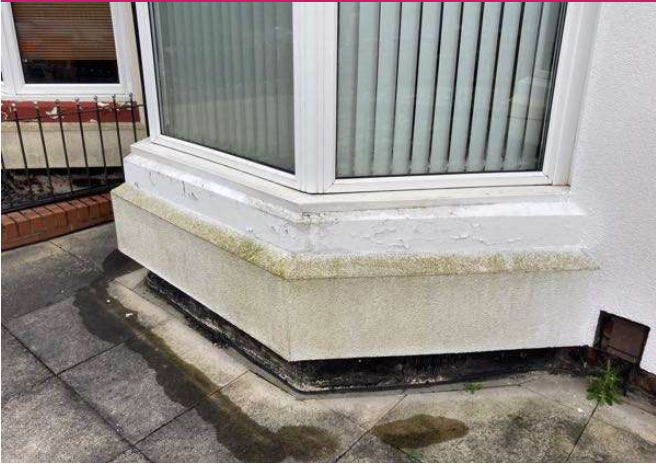
21-11-2022 12:32 / External Windows / Kzfyfont0

<b>Windows, sills and frame</b>	Good	<b>Property walls</b>	Fair
---------------------------------	------	-----------------------	------

Under window paint turning green  
Paint flaking on windowsill

Front and back walls turning green

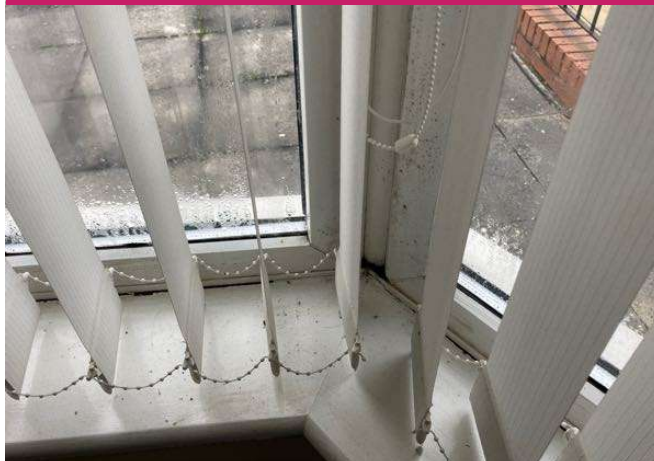
21-11-2022 12:35 / Windows Sills / Shxjiuw11

<b>Walls and ceiling</b>	Good	<b>Flooring</b>	Good
Photo code: poz7meqn5			
<b>Woodwork and doors</b>	Good	<b>Windows and sills</b>	Good
		Can see mould speckles around window	
		Photo code: shxjiuw11	
<b>Landlord's furnishings</b>	Good

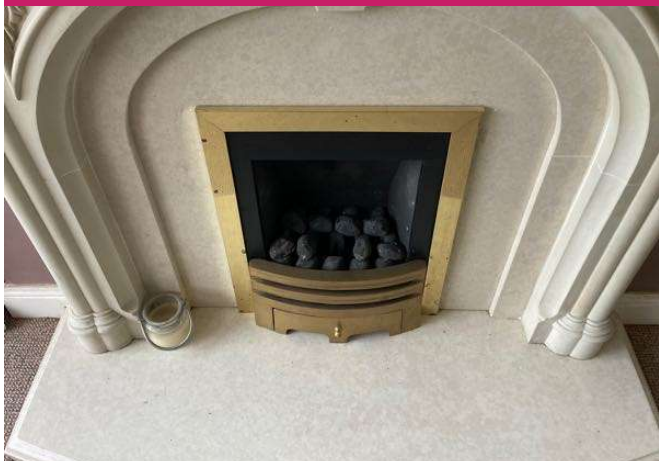
21-11-2022 12:42 / Internal Heating / Gqdy2rk9d

<b>Light and electrical fittings</b>	Good	<b>Leaks or leak damage?</b>	No
Collecting dust, needs a clean.			
<b>Heating</b>	Requires attention	<b>Mould or damp?</b>	No
Been condemned on last gas safety, can this be reinstated?			
Photo code: gqdy2rk9d			
<b>Natural lighting?</b>	Good	<b>Room layout - is it safe / fit for purpose?</b>	Good

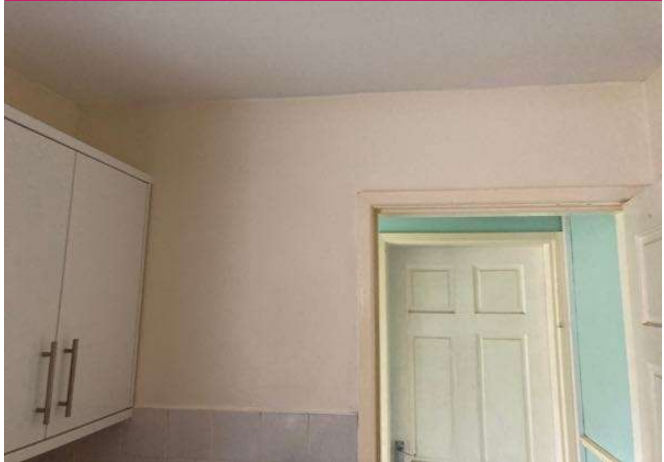
21-11-2022 12:36 / Kitchen Walls Ceilings / V85kbydrq

End wall looks good after damp decoration  
Various markings on other areas

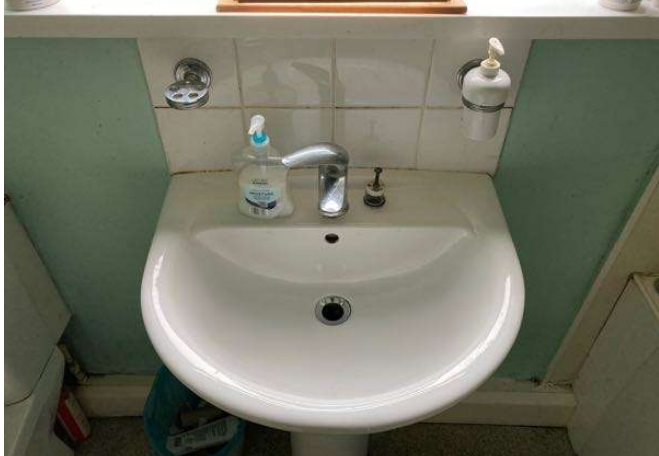
21-11-2022 12:37 / Sanitary Ware / Zjwlvdg7c

<b>Walls and ceiling</b>	Fair	<b>Woodwork and doors</b>	Good
<b>Windows and sills</b>	Good	<b>Sanitary ware</b>	Good
Photo code: rpjn3k0ry		Grouting a bit discoloured on the tiles	
		Photo code: zjwlvdg7c	
<b>Shower and attachments</b>	Fair	<b>Silicone seals</b>	Fair
Grubby around the base of the shower screen door		Some mould present around seals	
Photo codes: pqywo1meq, 20bmbtg5t		Photo codes: zxrwc30h2, zx1xc42kq	
<b>Tiles and grout</b>	Poor	<b>Extractor fan</b>	Good
<b>Light and electrical fittings</b>	Good	<b>Leaks or leak damage</b>	No

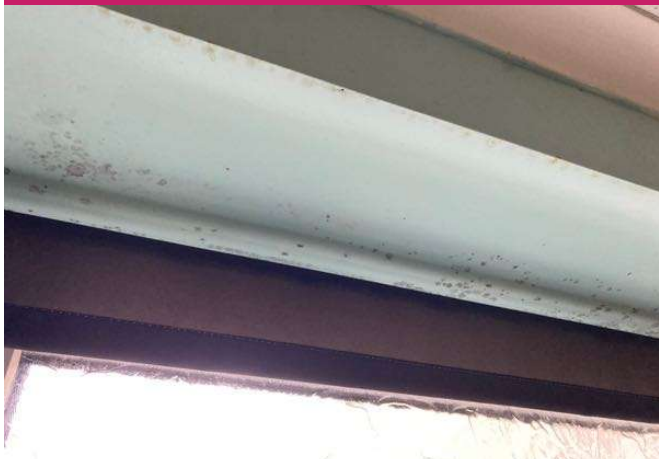
21-11-2022 12:38 / Bathroom Windows Sills / Rpjn3k0ry

<b>Mould or damp?</b>	Yes	<b>Natural lighting?</b>	Good
Mould speckles around window			
<b>Room layout - is it safe / fit for purpose?</b>	Good

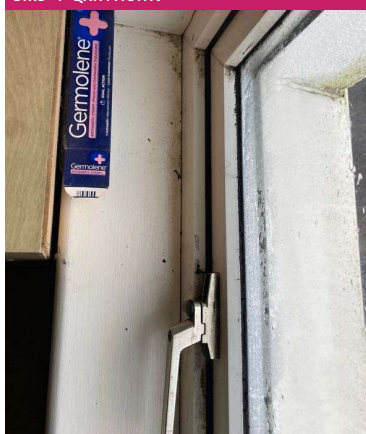
21-11-2022 12:41 / Bedroom Windows Sills / Qkif7homv

<b>Walls and ceiling</b>	Good	<b>Flooring</b>	Good
<b>Woodwork and doors</b>	Good	<b>Windows and sills</b>	Fair
		Mould speckles around frame and the tenant says it can be leaky. Photo code: qkif7homv	
<b>Light and electrical fittings</b>	Good	<b>Leaks or leak damage?</b>	No
<b>Heating</b>	Good

No maintenance issues to report but the tenant mentioned that the master bedroom window can be leaky but doesn't expect any work to be done.

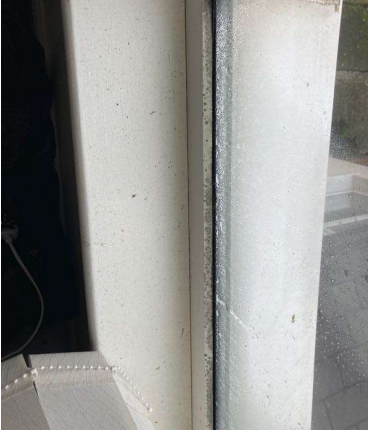
21-11-2022 12:40 / Bedroom Windows Sills / We4fxgebh

<b>Walls and ceiling</b>	Good	<b>Flooring</b>	Fair
<b>Woodwork and doors</b>	Good	<b>Windows and sills</b>	Good
		Mould speckles around frame Photo code: we4fxgebh	
<b>Light and electrical fittings</b>	Good	<b>Leaks or leak damage?</b>	No
<b>Heating</b>	Good

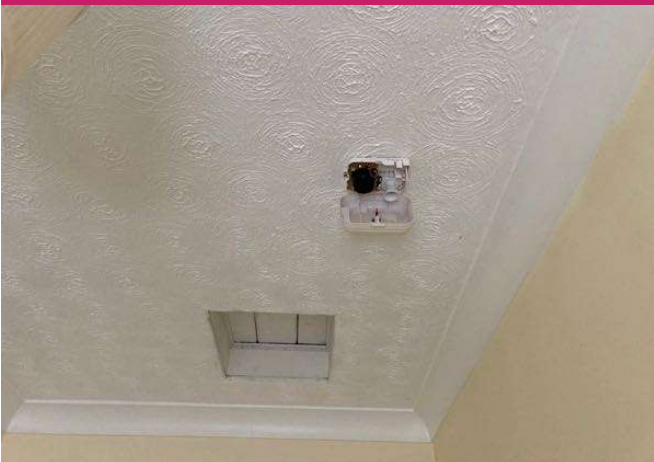
21-11-2022 12:41 / Smoke Detector Floor2 / V29edoz99

**Smoke Detector on Floor 2?** Yes

Type	Battery	Tested?	Not tested

**Notes** Not connected
