## Property Visit Report

11 The Groves, STOCKTON-ON-TEES, Durham TS18 3PU

**Report date:** 21st November 2022

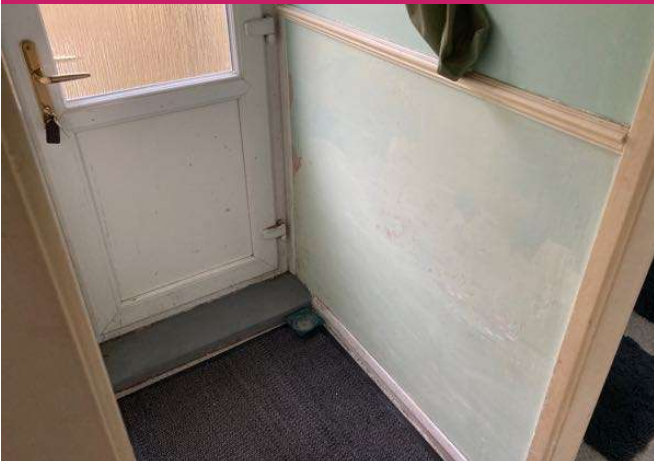
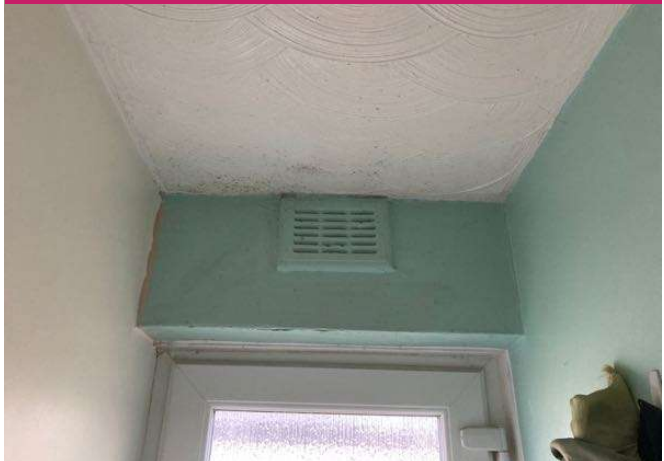
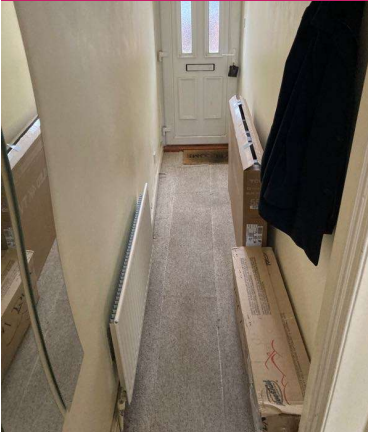
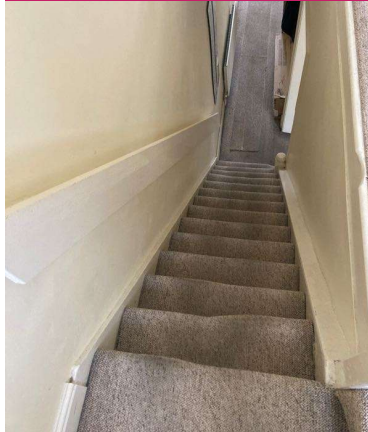
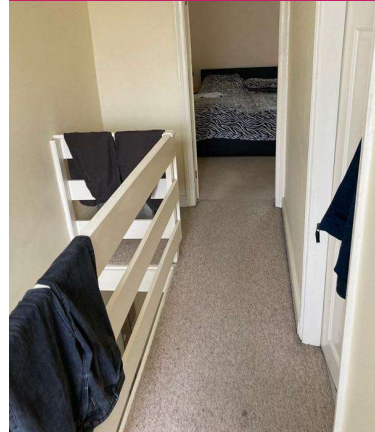
<b>Walls and ceiling</b>	Fair	<b>Flooring</b>	Fair
Paint work would benefit being touched up		The carpet has darkened from where people walk up and down the stairs	
<b>Woodwork and doors</b>	Fair

<b>Light and electrical fittings</b>	Good	<b>Leaks or leak damage?</b>	No
<b>Mould or damp?</b>	Yes	<b>Natural lighting?</b>	Good
Mould around air vent above front door			
<b>Room layout - is it safe / fit for purpose?</b>	Good

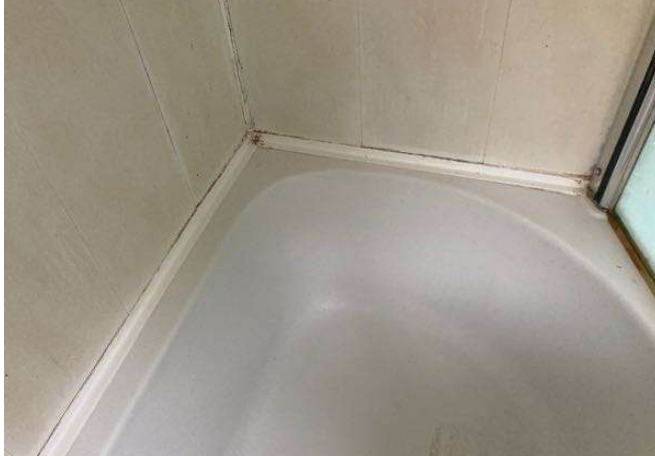
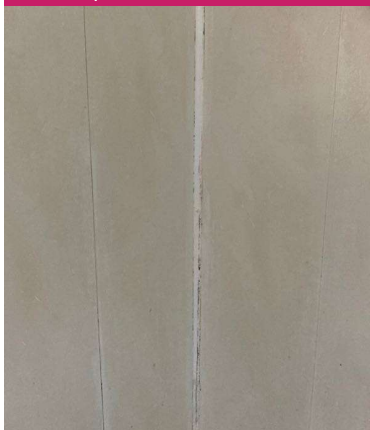
21-11-2022 12:37 / Silicone Seals / Zxrcw30h2

<b>Walls and ceiling</b>	Fair	<b>Woodwork and doors</b>	Good
<b>Windows and sills</b>	Good	<b>Sanitary ware</b>	Good
Photo code: rpjn3k0ry		Grouting a bit discoloured on the tiles	
		Photo code: zjwlvdg7c	
<b>Shower and attachments</b>	Fair	<b>Silicone seals</b>	Fair
Grubby around the base of the shower screen door		Some mould present around seals	
Photo codes: pqywo1meq, 20bmbtg5t		Photo codes: zxrwc30h2, zx1xc42kq	
<b>Tiles and grout</b>	Poor	<b>Extractor fan</b>	Good
<b>Light and electrical fittings</b>	Good	<b>Leaks or leak damage</b>	No
