Meridian Heating

Landlord Gas Safety Record

Water Test Results

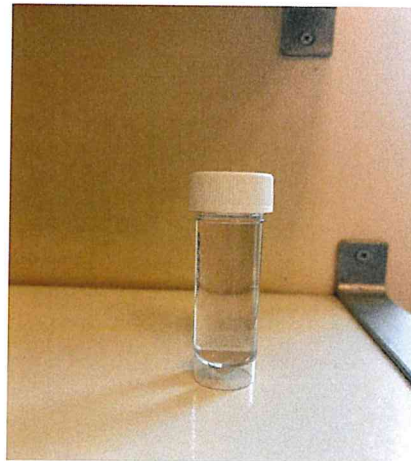
Water Sample

Test	Result
Inhibitor Level	Recommendation
Corrosion Level	Pass
pH Level	Pass

- Insufficient Inhibitor detected, top up required. Use Adey MC1+ (or equivalent). Ensure to circulate for 30 minutes in the system and test again.
- Corrosion level is low, no further action required
- pH level ok, no further action required
